**Alpine Satellite Development Plan
Final Environmental Impact Statement**

CLOVER MINE SITE REHABILITATION PLAN

ECOLOGICAL RESTORATION OF THE CLOVER A MINE SITE, ALPINE SATELLITE DEVELOPMENT PROJECT, ALASKA

July 2004

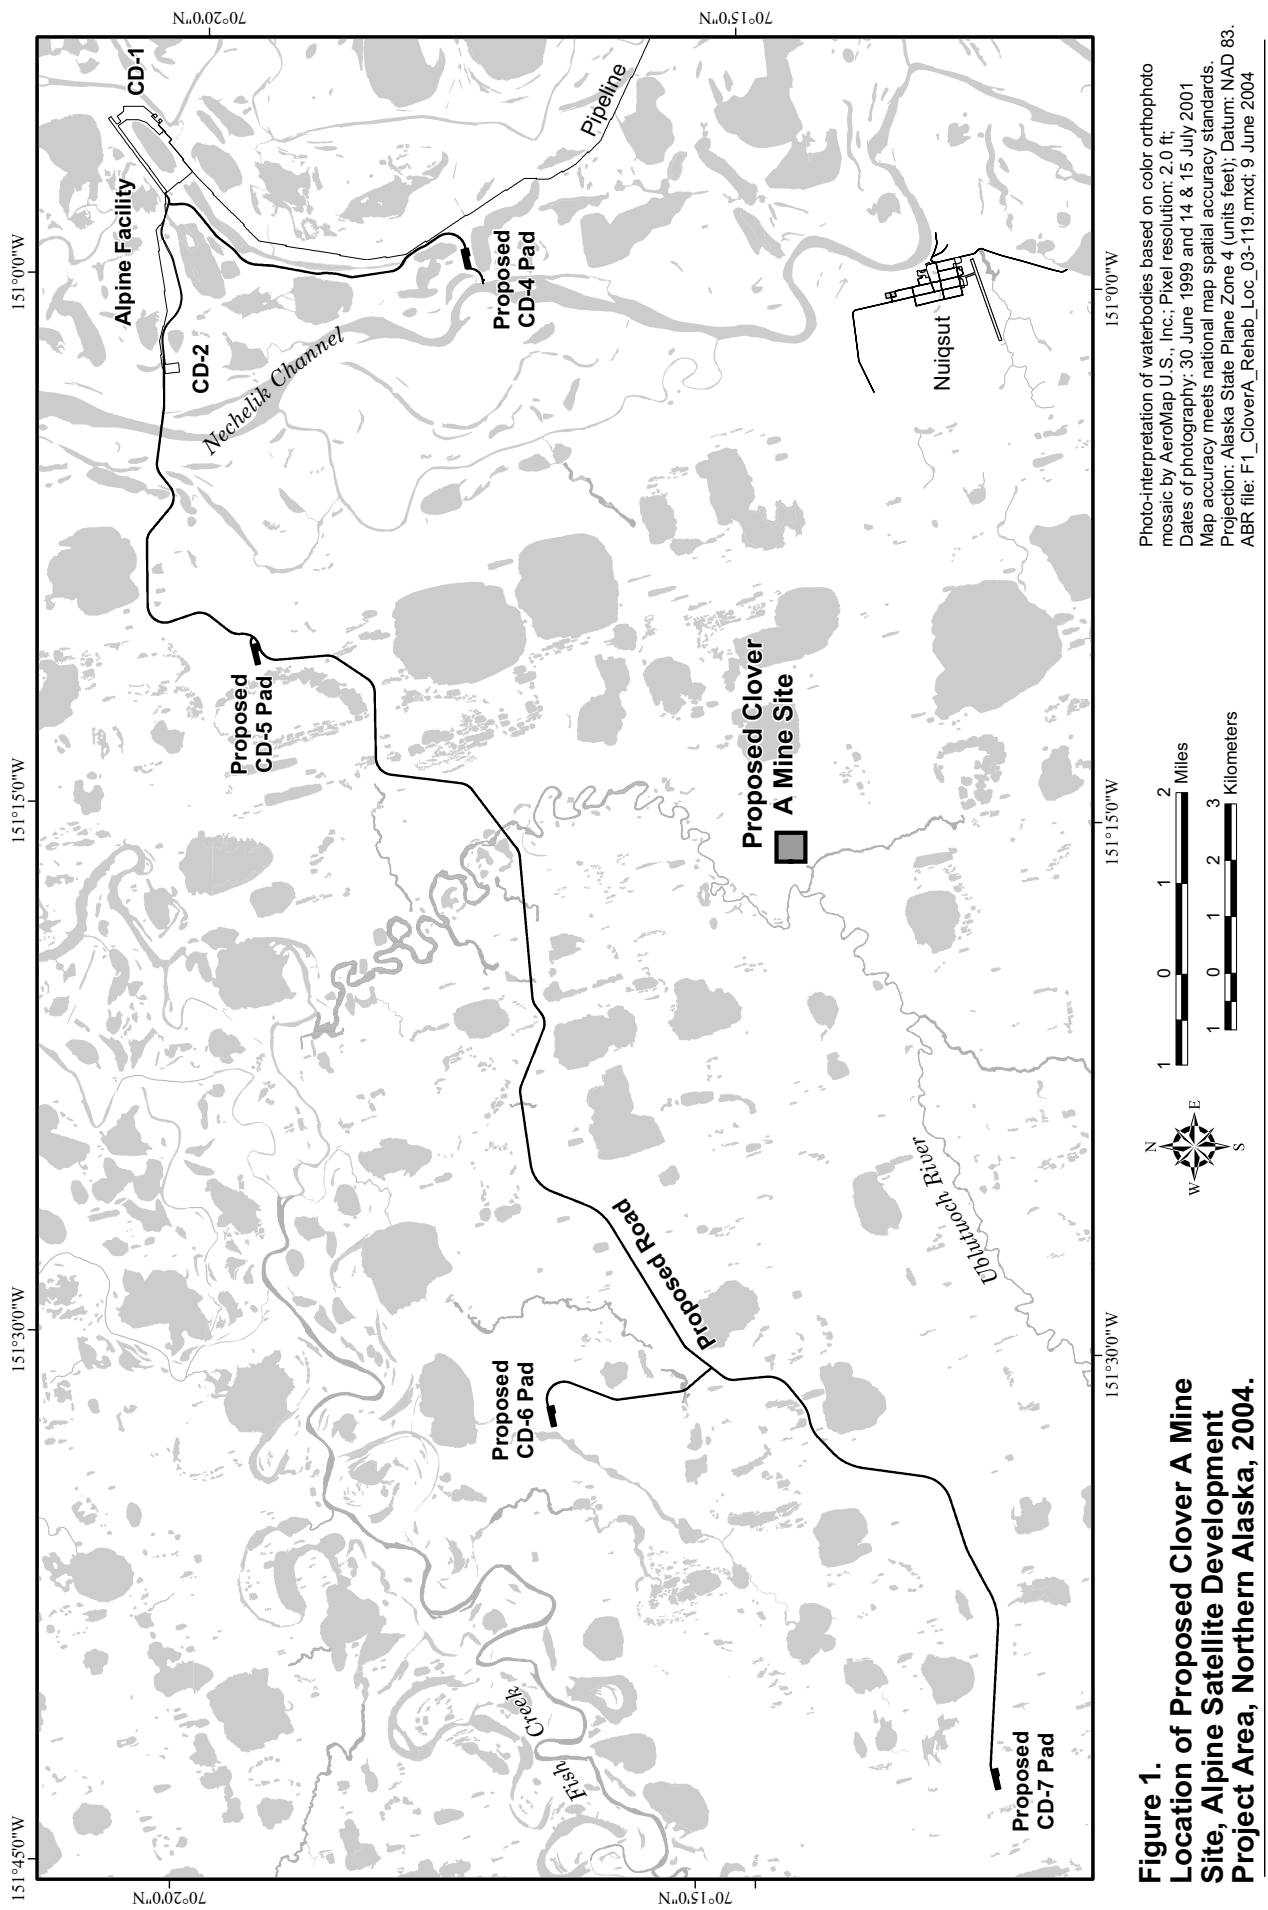
Figure 1.
Location of Proposed Clover A Mine
Site, Alpine Satellite Development
Project Area, Northern Alaska, 2004.

The proposed Clover A Mine Site is located in the National Petroleum Reserve Alaska (NPRA), approximately 13.8 km east of the Alpine Oilfield and 13 km south of Harrison Bay (Figure 1). The vegetation consists primarily of Moist Sedge-Shrub Meadow and Moist Tussock Tundra. Small inclusions of Patterned Wet Meadow also occur within the Moist Tussock Tundra (Figure 2) Restoration plans for this mine site call for the creation of high-value waterbird habitat, which is uncommon in this area.

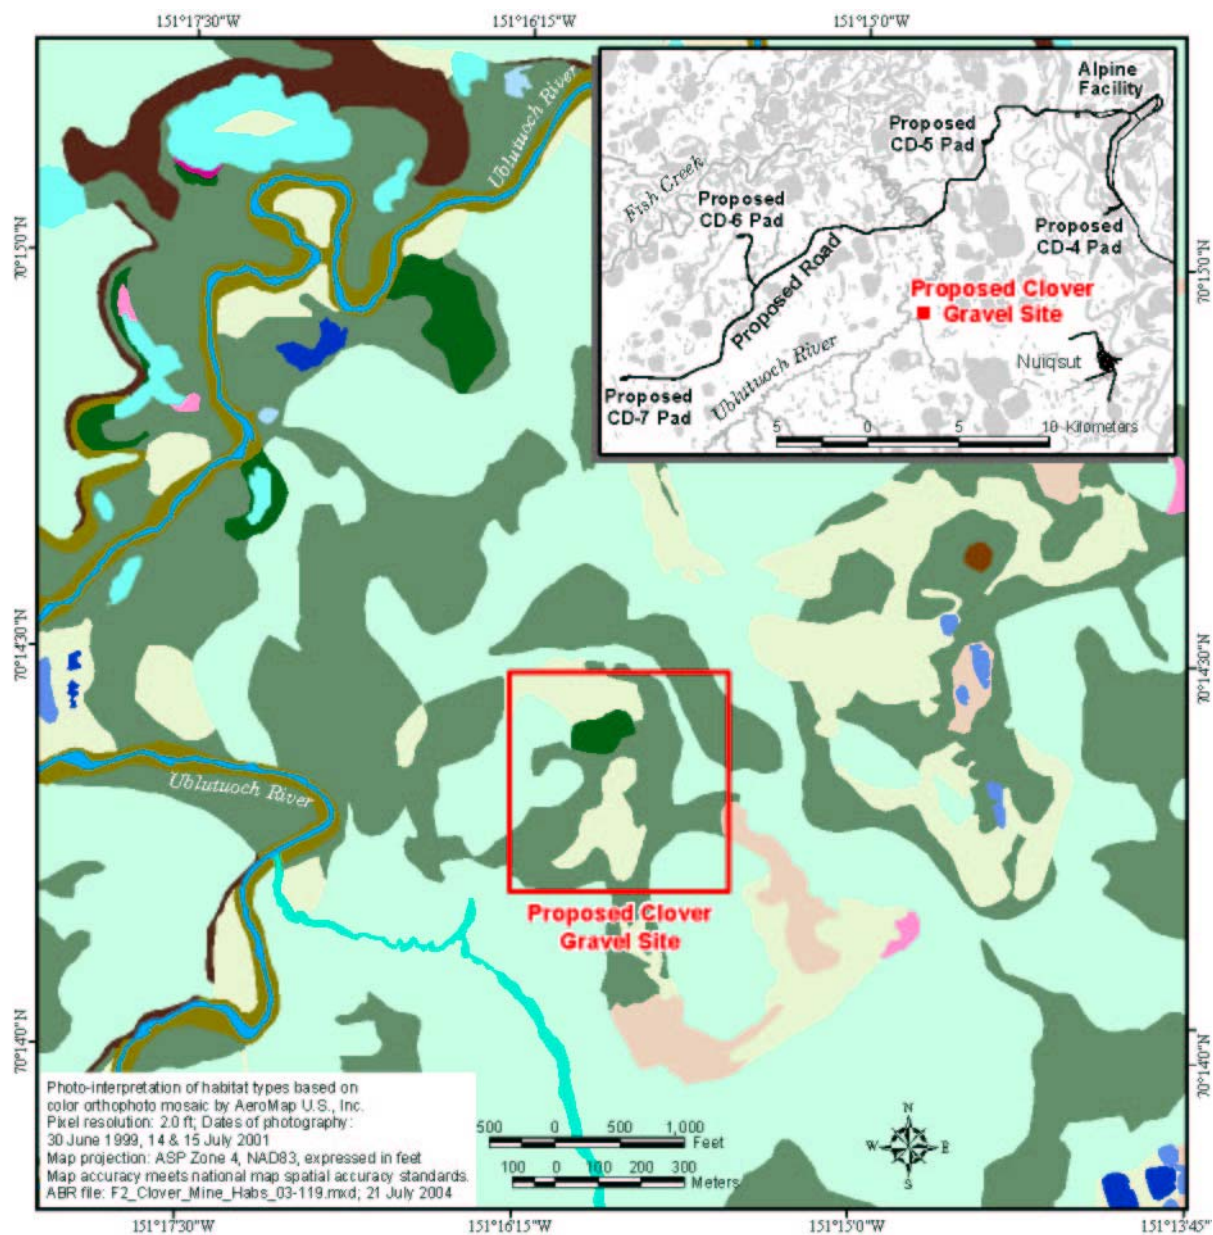
Figure 2.
Wildlife Habitats near
the Proposed Clover
Gravel Site, ASDP Area,
Northern Alaska, 2004.

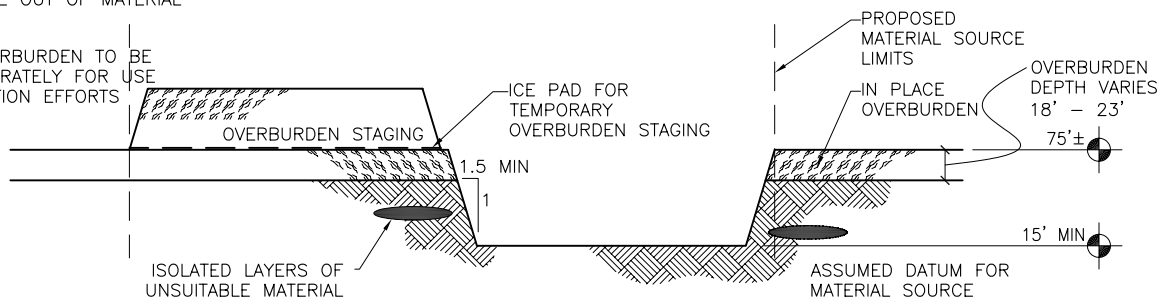
SECTION

PROPOSED MATERIAL
SOURCE LIMITS

YEAR 1
ORGANIC
OVERBURDEN
STAGING AREA

YEAR 1 BULK
OVERBURDEN
STAGING AREA

DIRECTION OF
EXCAVATION

YEAR 1
EXCAVATION
AREA

- OVERBURDEN TO BE STAGED WITHIN MATERIAL SOURCE LIMITS FOR USE IN REMEDIATION OF MATERIAL SOURCE AREA UPON YEAR'S CLOSE OUT OF MATERIAL SOURCE.
- ORGANIC OVERBURDEN TO BE STAGED SEPARATELY FOR USE IN REVEGETATION EFFORTS

ALPINE SATELLITE DEVELOPMENT PROGRAM
CLOVER A GRAVEL SOURCE, DRAWING 1 OF 3
YEAR 1

Materials unsuitable for road or pad construction will remain within the proposed material source boundaries and will be used in rehabilitating the mine site once mining is complete. Construction activities are currently scheduled for two winter construction seasons, not necessarily concurrent (Appendix Figures 1 and 2). An exposed working face will remain open after the first year's mining efforts. The site will be accessed using seasonal ice roads.

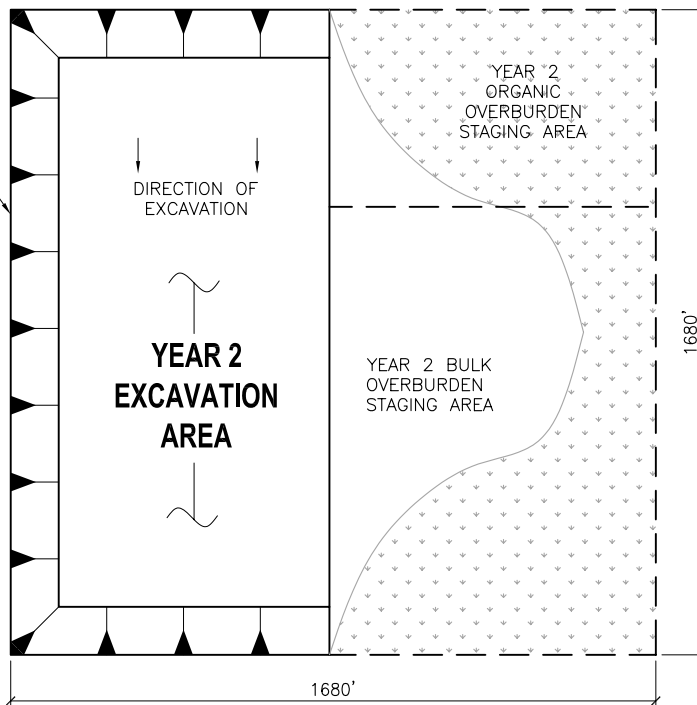
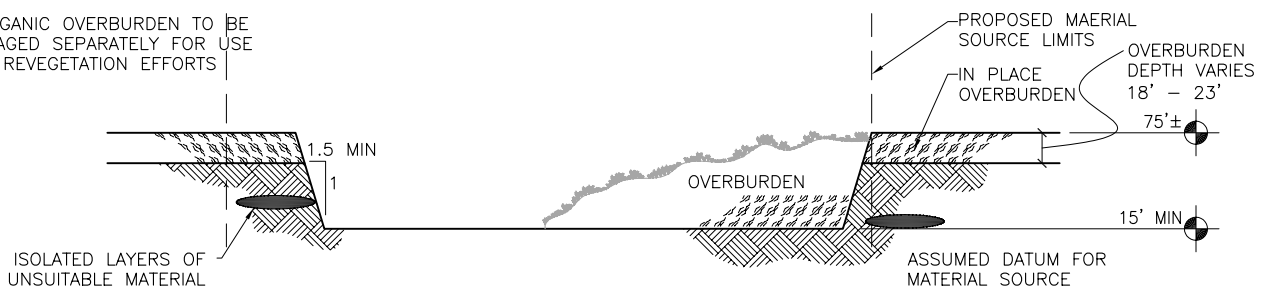
PLAN

PROPOSED MATERIAL
SOURCE EXCAVATION
LIMITS

- OVERBURDEN TO BE PLACED IN REMEDIATION AREA UPON YEAR'S CLOSE OUT OF MATERIAL SOURCE.
- ORGANIC OVERBURDEN TO BE STAGED SEPARATELY FOR USE IN REVEGETATION EFFORTS

ALPINE SATELLITE DEVELOPMENT PROGRAM
CLOVER A GRAVEL SOURCE, DRAWING 2 OF 3
YEAR 2

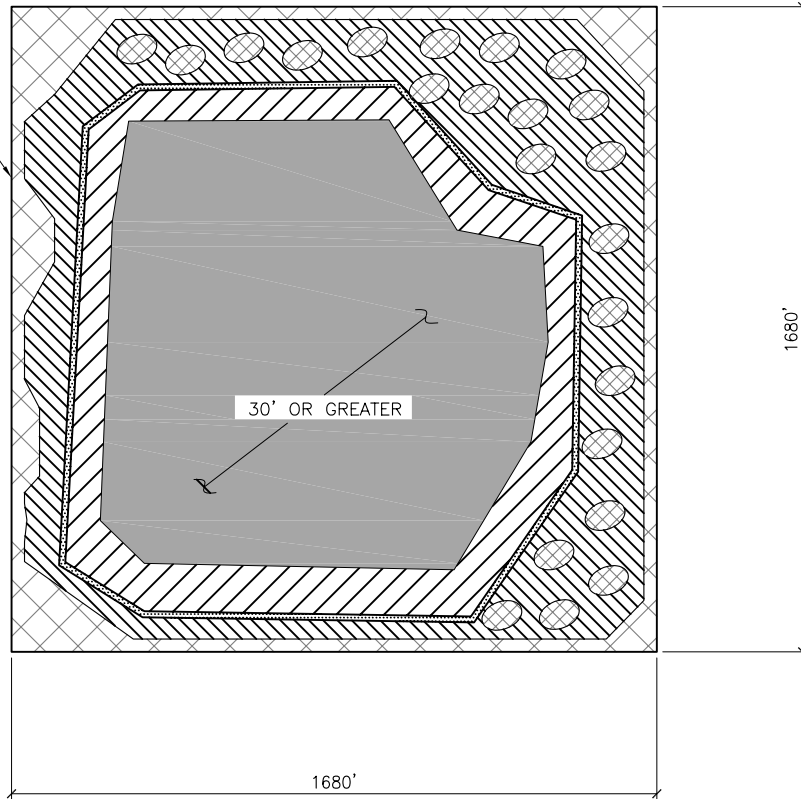
PLAN

MATERIAL SOURCE LIMITS
